MACHINE SERVICE BULLETIN NO. 358

SUBJECT: Reversals
LA-5 and LA-6 Models

DATE: July 19, 1940

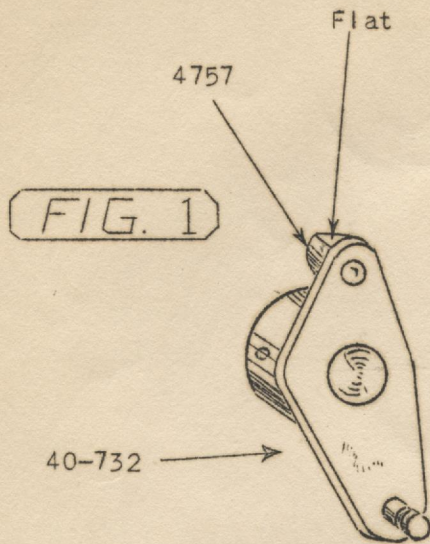
The 4757 stud on the 40-732 and 41-732 crank arm of the carry shaft has a flat side which serves the purpose of retarding the clutch yoke until the proper time for it to move its position from plus to minus or vice versa. See Fig. 1.

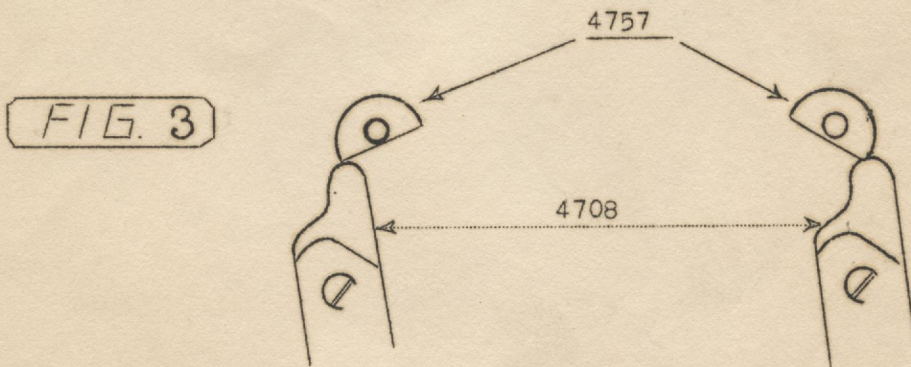
The two edges of this flat side move the clutch yoke into the plus or minus position according to the direction the machine starts to cycle. As the 40-732 or 41-732 turns, the edge of the flat side will contact the center point of the top of the 4708 blank and cause the yoke to move into the position desired (provided the 4708 is correctly adjusted) and the flat of the 4757 stud will prevent movement of the yoke in the wrong direction if it should receive a rebound from some source. See Figures 3 and 4.
